CREEP BEHAVIOR OF OXIDE/OXIDE COMPOSITES
WITH MONAZITE FIBER COATING
AT 1100 °C IN AIR AND IN STEAM ENVIRONMENTS

THESIS

AFIT/GA/ENY/08-S01

The creep behavior of six oxide-oxide ceramic-matrix composites (CMCs) was investigated at 1100 °C in laboratory air and in steam environments. The six CMC systems had an alumina (Al_2O_3) matrix reinforced with NextelTM610 fibers. The CMC systems C1, C2 and C3 were reinforced with 10 uni-directional fiber layers in a symmetric cross-ply (0°/90°/0°/90°/0°)_s orientation. In the case of composites C2 and C3, monazite (LaPO_4) fiber coating was applied to the fibers. Composite C1 contained no fiber coating. In the case of composites C1 and C2, alumina matrix was infiltrated with monazite. The CMC systems C4, C5, and C6 were reinforced with 8 plies of fiber fabric woven in a balanced eight-harness satin weave (8HSW). In the case of composites C4 and C6, monazite (LaPO_4) fiber coating was applied to the fibers. Composite C5 contained no fiber coating. In the case of composite C6, alumina matrix was infiltrated with AlOCl . The tensile stress-strain behaviors of the six CMC systems were investigated, and the tensile properties measured at 1100 °C

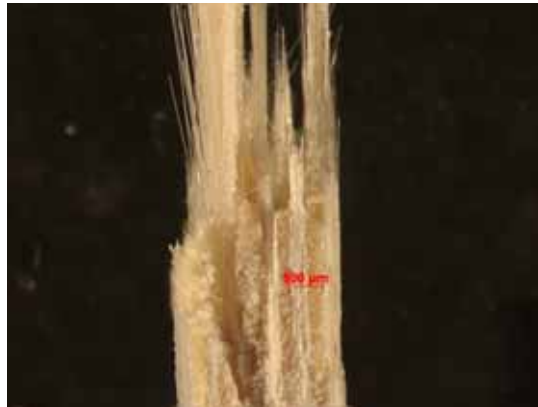
Figure B.89: Fracture surface of the N610/LaPO₄/Al₂O₃ specimen with 10ply 0°/90° uni-tape lay-up subjected to creep test at 120 MPa in air at 1100 °C ($t_f = 0.74$ h).

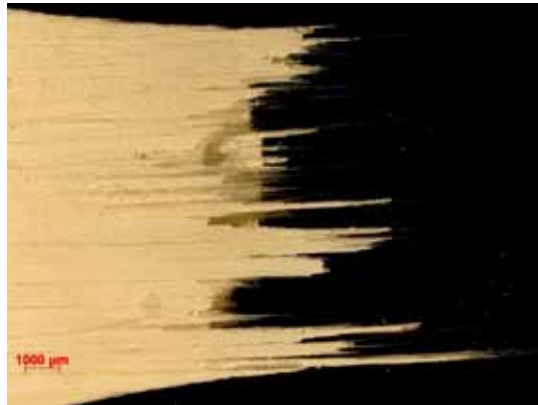
Figure B.91: Fracture surface of the N610/LaPO₄/Al₂O₃ specimen with 10ply 0°/90° uni-tape lay-up subjected to creep test at 120 MPa in steam at 1100 °C ($t_f = 0.03$ h).

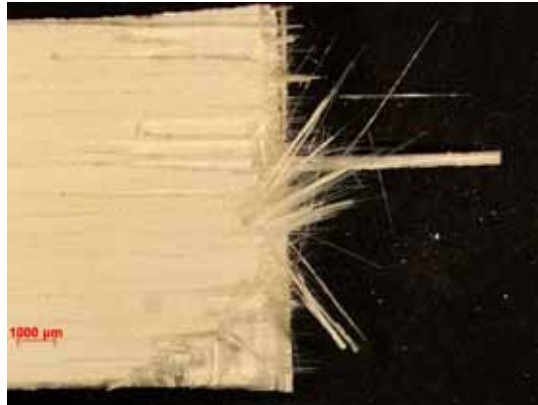
Figure B.94: Fracture surface of the N610/LaPO₄/Al₂O₃ specimen with 10ply 0°/90° uni-tape lay-up subjected to creep test at 120 MPa in steam at 1100 °C ($t_f = 0.03$ h).

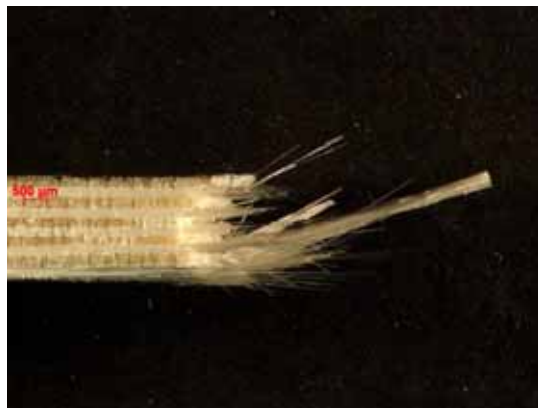
Figure B.95: Fracture surface of the N610/LaPO₄/Al₂O₃ specimen with 10ply 0°/90° uni-tape lay-up subjected to creep test at 120 MPa in steam at 1100 °C ($t_f = 0.03$ h).

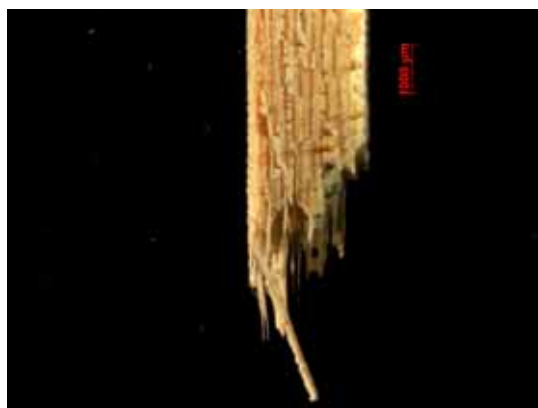
Figure B.99: Fracture surface of the N610/LaPO₄/Al₂O₃ specimen with 8ply HSW subjected tension to failure in laboratory air at 1100 °C.

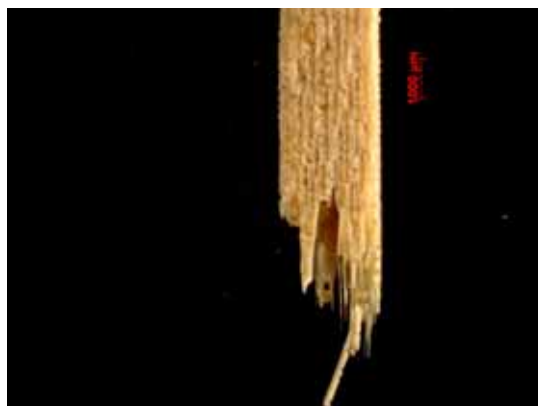
Figure B.100: Fracture surface of the N610/LaPO₄/Al₂O₃ specimen with 8ply HSW subjected tension to failure in laboratory air at 1100 °C.

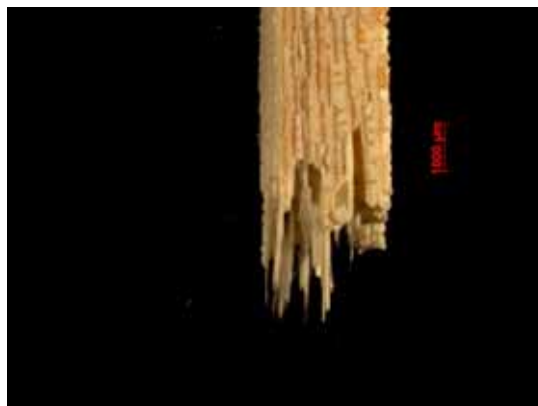
Figure B.104: Fracture surface of the N610/LaPO₄/Al₂O₃ specimen with 8ply HSW subjected tension to failure in laboratory air at 1100 °C.

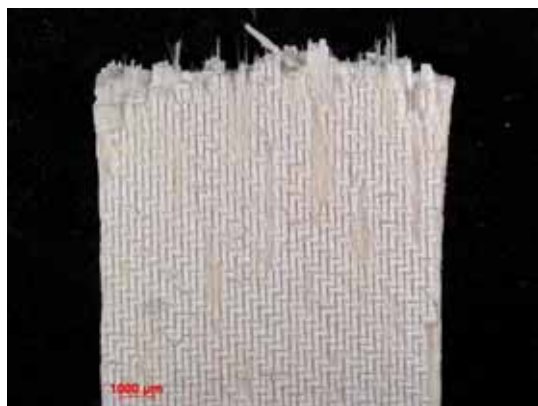
Figure B.106: Fracture surface of the N610/LaPO₄/Al₂O₃ specimen with 8ply HSW subjected tension to failure in laboratory air at 1100 °C.

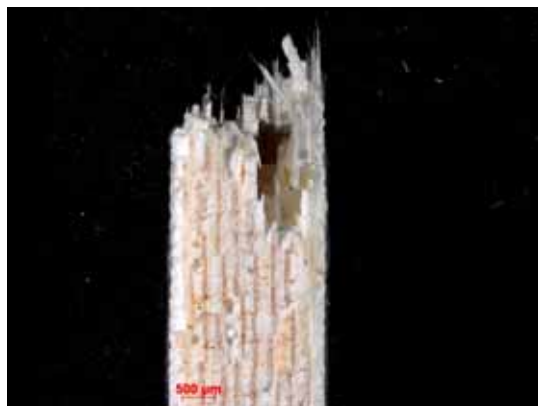
Figure B.107: Fracture surface of the N610/LaPO₄/Al₂O₃ specimen with 8ply HSW subjected tension to failure in laboratory air at 1100 °C.

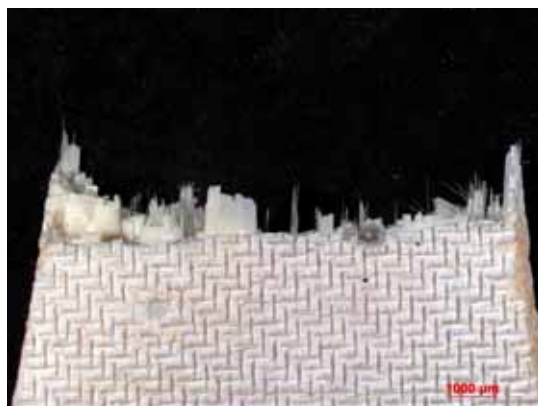
Figure B.109: Fracture surface of the N610/LaPO₄/Al₂O₃ specimen with 8ply HSW subjected tension to failure in laboratory air at 1100 °C.

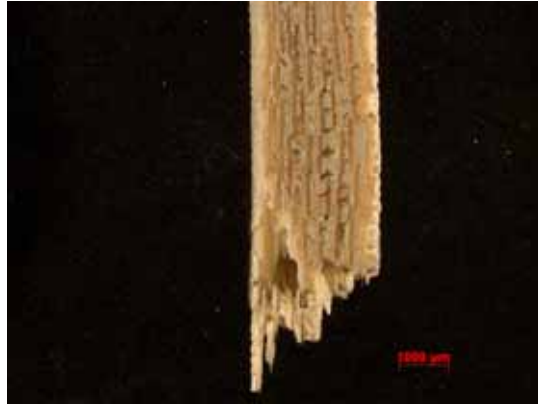
Figure B.113: Fracture surface of the N610/LaPO₄/Al₂O₃ specimen with 8ply HSW subjected subjected to creep test at 32 MPa in air at 1100 °C ($t_f > 100$ h).

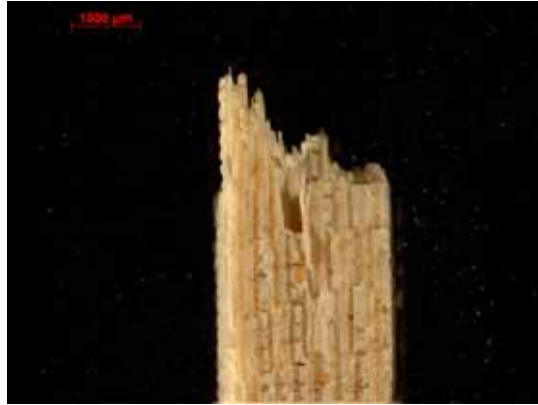
Figure B.116: Fracture surface of the N610/LaPO₄/Al₂O₃ specimen with 8ply HSW subjected subjected to creep test at 32 MPa in air at 1100 °C ($t_f > 100$ h).

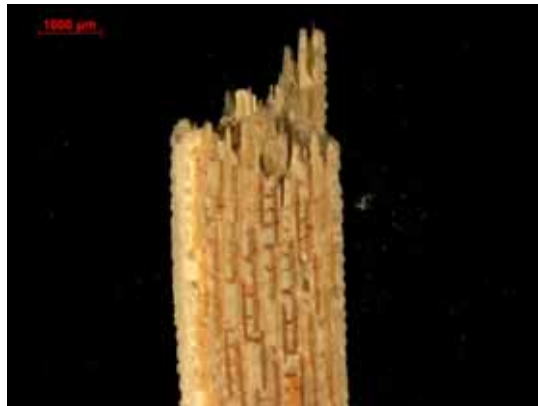
Figure B.117: Fracture surface of the N610/LaPO₄/Al₂O₃ specimen with 8ply HSW subjected subjected to creep test at 32 MPa in air at 1100 °C ($t_f > 100$ h).

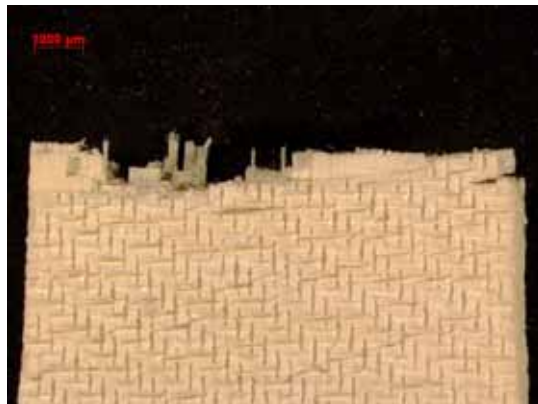
Figure B.118: Fracture surface of the N610/LaPO₄/Al₂O₃ specimen with 8ply HSW subjected subjected to creep test at 32 MPa in steam at 1100 °C ($t_f = 51.9$ h).

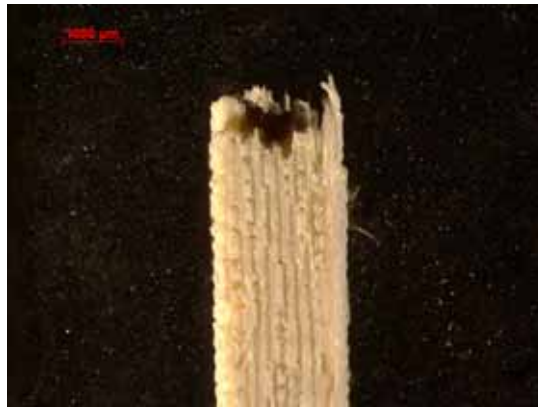
Figure B.120: Fracture surface of the N610/LaPO₄/Al₂O₃ specimen with 8ply HSW subjected subjected to creep test at 32 MPa in steam at 1100 °C ($t_f = 51.9$ h).

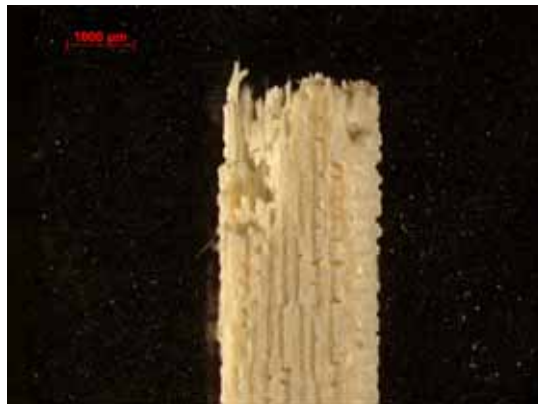
Figure B.121: Fracture surface of the N610/LaPO₄/Al₂O₃ specimen with 8ply HSW subjected subjected to creep test at 32 MPa in steam at 1100 °C ($t_f = 51.9$ h).

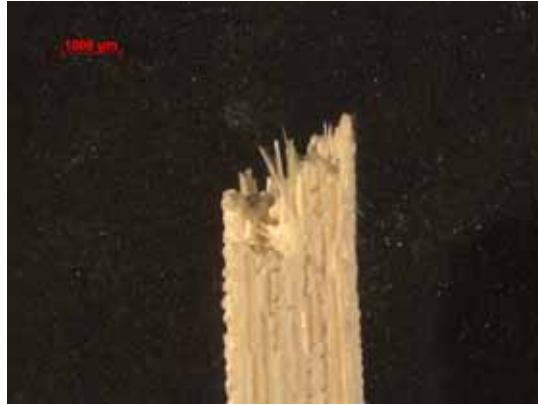
Figure B.122: Fracture surface of the N610/LaPO₄/Al₂O₃ specimen with 8ply HSW subjected subjected to creep test at 32 MPa in steam at 1100 °C ($t_f = 51.9$ h).

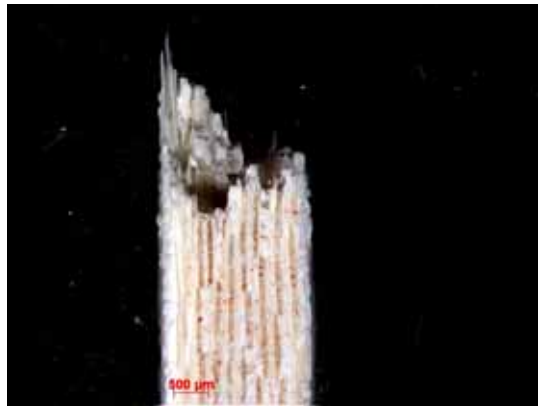
Figure B.129: Fracture surface of the N610/LaPO₄/Al₂O₃ specimen with 8ply HSW subjected subjected to creep test at 64 MPa in air at 1100 °C ($t_f > 100$ h).

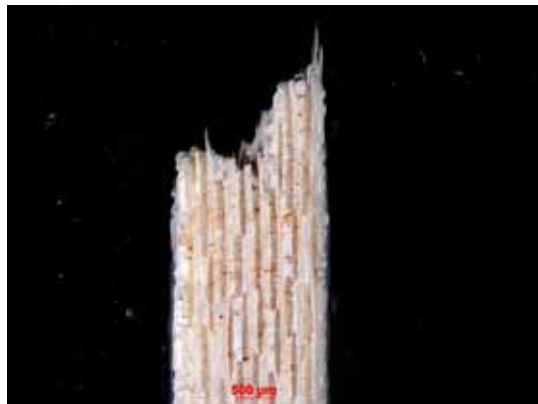
Figure B.130: Fracture surface of the N610/LaPO₄/Al₂O₃ specimen with 8ply HSW subjected subjected to creep test at 64 MPa in air at 1100 °C ($t_f > 100$ h).

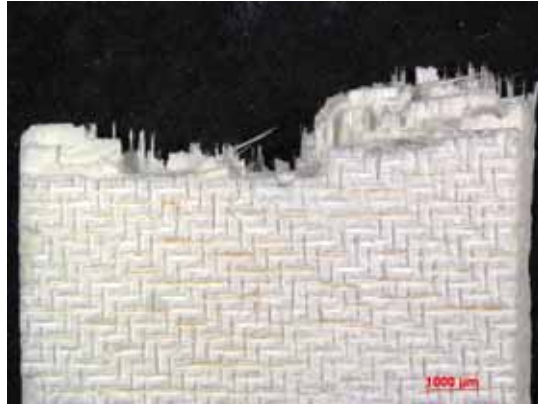
Figure B.131: Fracture surface of the N610/LaPO₄/Al₂O₃ specimen with 8ply HSW subjected subjected to creep test at 48 MPa in steam at 1100 °C ($t_f = 7.58$ h).

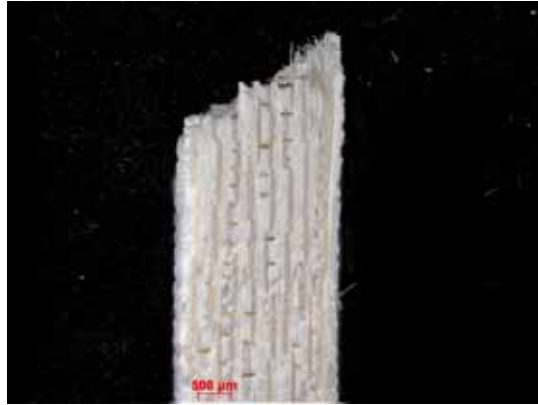
Figure B.134: Fracture surface of the N610/LaPO₄/Al₂O₃ specimen with 8ply HSW subjected subjected to creep test at 48 MPa in steam at 1100 °C ($t_f = 7.58$ h).

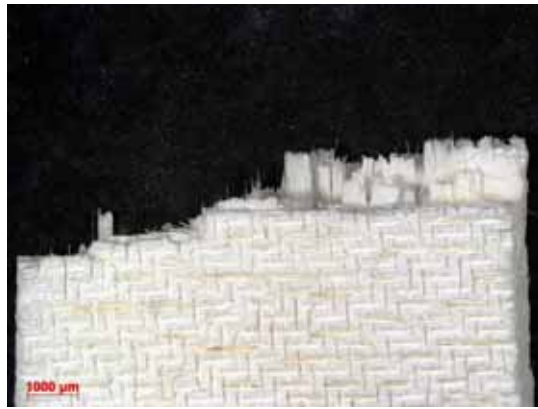
Figure B.135: Fracture surface of the N610/LaPO₄/Al₂O₃ specimen with 8ply HSW subjected subjected to creep test at 48 MPa in steam at 1100 °C ($t_f = 7.58$ h).

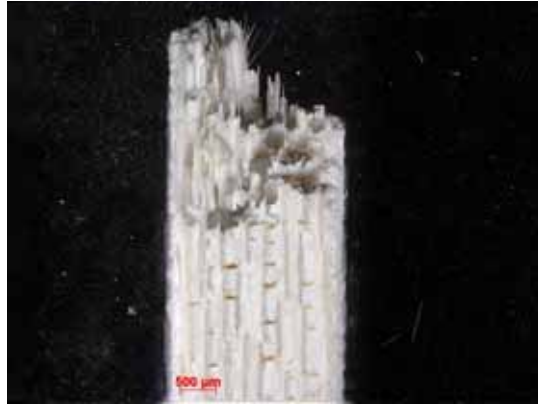
Figure B.137: Fracture surface of the N610/LaPO₄/Al₂O₃ specimen with 8ply HSW subjected subjected to creep test at 48 MPa in steam at 1100 °C ($t_f = 7.58$ h).

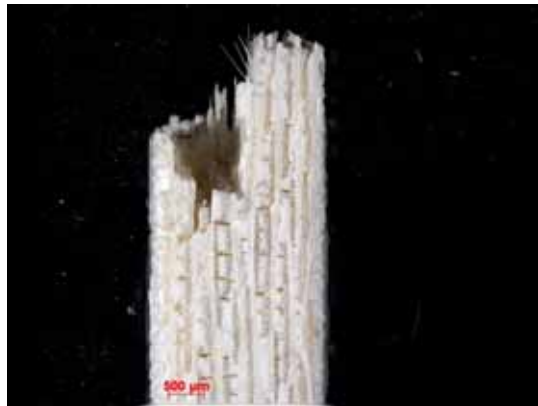
Figure B.138: Fracture surface of the N610/LaPO₄/Al₂O₃ specimen with 8ply HSW subjected subjected to creep test at 48 MPa in steam at 1100 °C ($t_f = 7.58$ h).

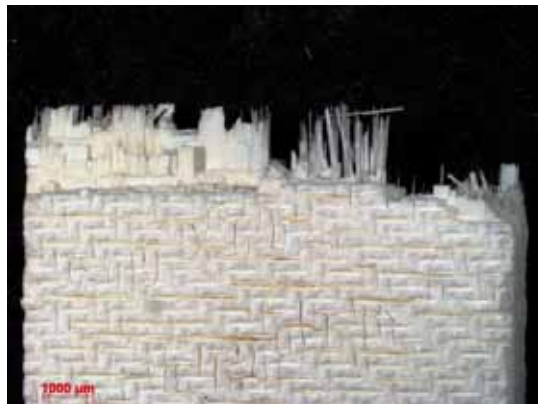
Figure B.139: Fracture surface of the N610/LaPO₄/Al₂O₃ specimen with 8ply HSW subjected subjected to creep test at 64 MPa in steam at 1100 °C ($t_f = 2.38$ h).

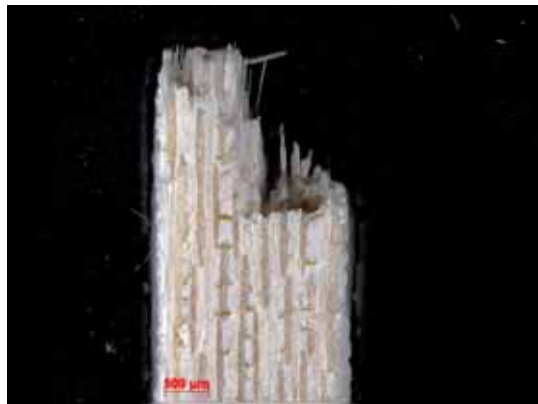
Figure B.142: Fracture surface of the N610/LaPO₄/Al₂O₃ specimen with 8ply HSW subjected subjected to creep test at 64 MPa in steam at 1100 °C ($t_f = 2.38$ h).

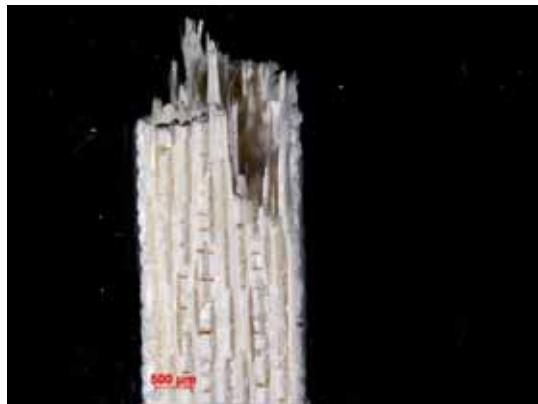
Figure B.145: Fracture surface of the N610/LaPO₄/Al₂O₃ specimen with 8ply HSW subjected subjected to creep test at 64 MPa in steam at 1100 °C ($t_f = 2.38$ h).

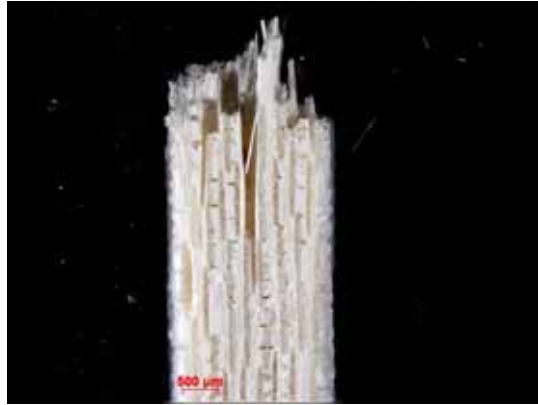
Figure B.146: Fracture surface of the N610/LaPO₄/Al₂O₃ specimen with 8ply HSW subjected subjected to creep test at 64 MPa in steam at 1100 °C ($t_f = 2.38$ h).

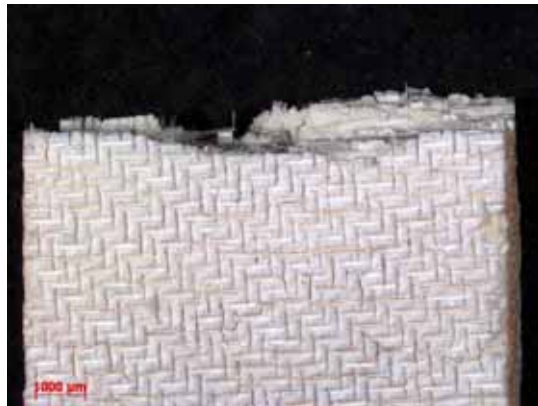
Figure B.147: Fracture surface of the N610/LaPO₄/Al₂O₃ specimen with 8ply HSW subjected subjected to creep test at 72 MPa in air at 1100 °C ($t_f > 100$ h).

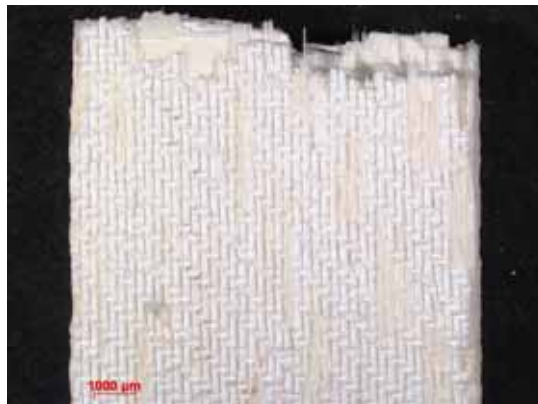
Figure B.148: Fracture surface of the N610/LaPO₄/Al₂O₃ specimen with 8ply HSW subjected subjected to creep test at 72 MPa in air at 1100 °C ($t_f > 100$ h).

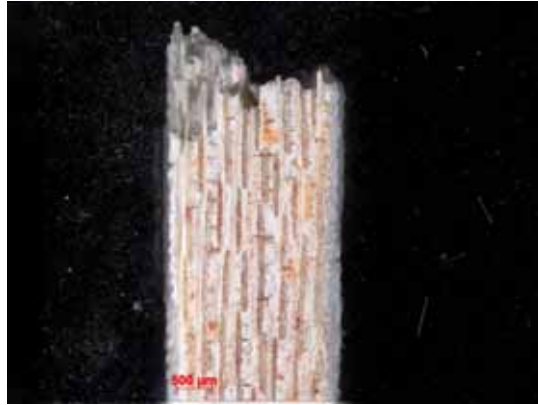
Figure B.149: Fracture surface of the N610/LaPO₄/Al₂O₃ specimen with 8ply HSW subjected subjected to creep test at 72 MPa in air at 1100 °C ($t_f > 100$ h).

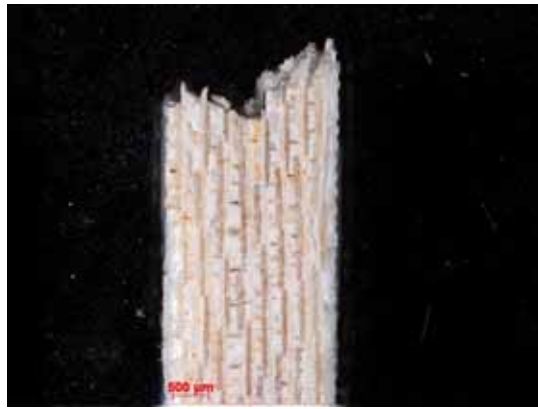
Figure B.150: Fracture surface of the N610/LaPO₄/Al₂O₃ specimen with 8ply HSW subjected subjected to creep test at 72 MPa in air at 1100 °C ($t_f > 100$ h).

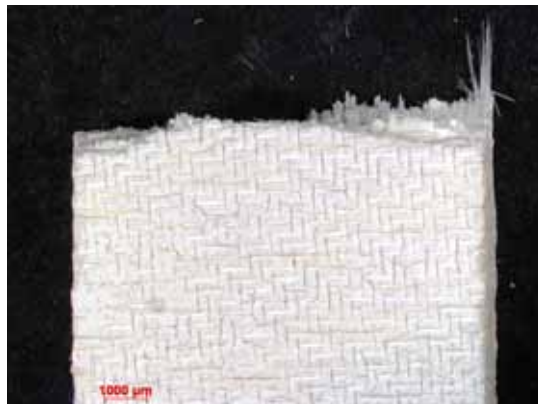
Figure B.151: Fracture surface of the N610/LaPO₄/Al₂O₃ specimen with 8ply HSW subjected subjected to creep test at 72 MPa in air at 1100 °C ($t_f > 100$ h).

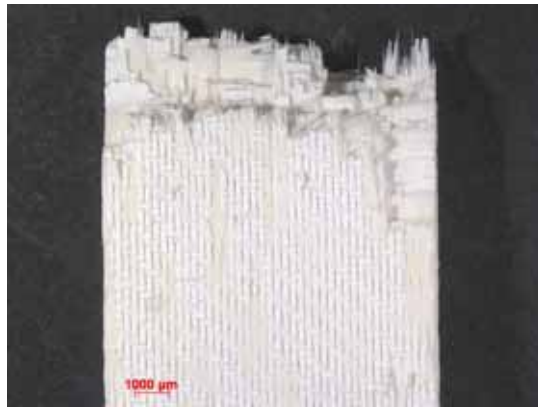
Figure B.153: Fracture surface of the N610/LaPO₄/Al₂O₃ specimen with 8ply HSW subjected subjected to creep test at 72 MPa in steam at 1100 °C ($t_f = 2.24$ h).

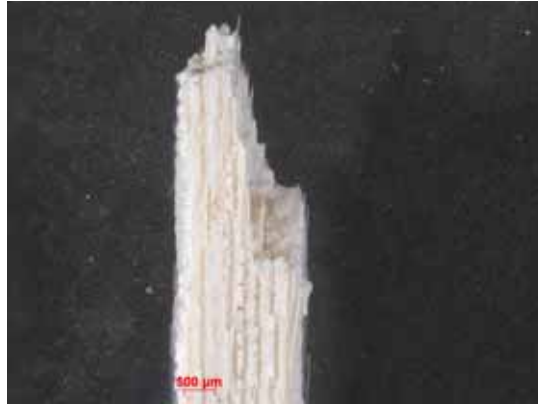
Figure B.155: Fracture surface of the N610/LaPO₄/Al₂O₃ specimen with 8ply HSW subjected subjected to creep test at 72 MPa in steam at 1100 °C ($t_f = 2.24$ h).

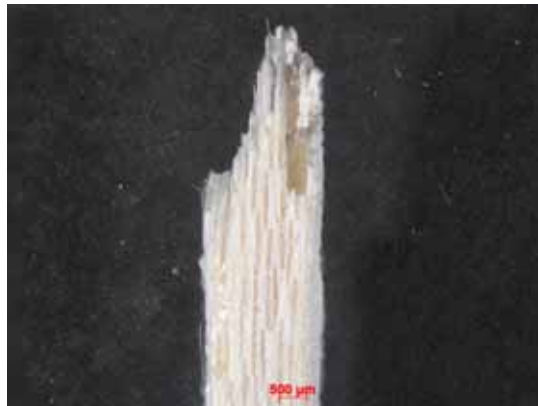
Figure B.156: Fracture surface of the N610/LaPO₄/Al₂O₃ specimen with 8ply HSW subjected subjected to creep test at 72 MPa in steam at 1100 °C ($t_f = 2.24$ h).

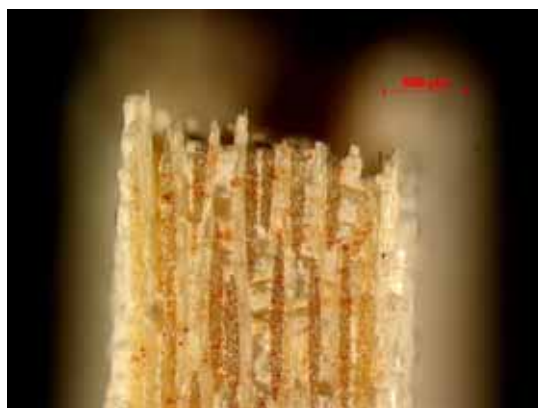
Figure B.165: Fracture surface of the N610/ Al_2O_3 specimen with 8ply HSW subjected tension to failure in laboratory air at 1100 °C.

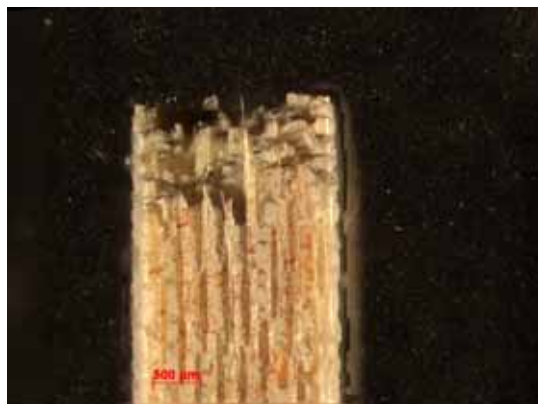
Figure B.173: Fracture surface of the N610/LaPO₄/Al₂O₃ specimen with 8ply HSW subjected subjected to creep test at 20 MPa in steam at 1100 °C ($t_f = 3.53$ h).

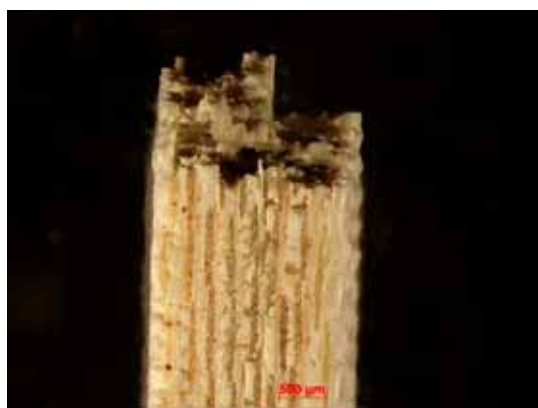
Figure B.177: Fracture surface of the N610/LaPO₄/Al₂O₃ specimen with 8ply HSW subjected subjected to creep test at 20 MPa in steam at 1100 °C ($t_f = 3.53$ h).

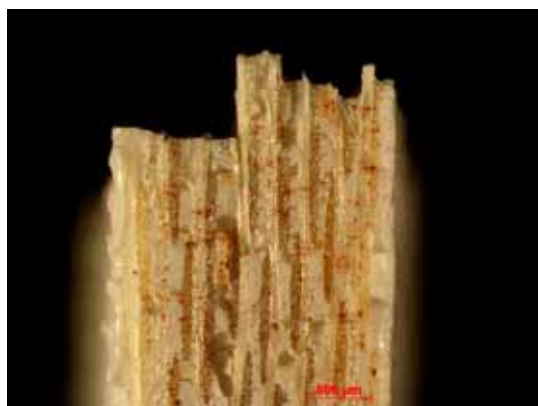
Figure B.178: Fracture surface of the N610/LaPO₄/Al₂O₃ specimen with 8ply HSW subjected subjected to creep test at 20 MPa in steam at 1100 °C ($t_f = 3.53$ h).

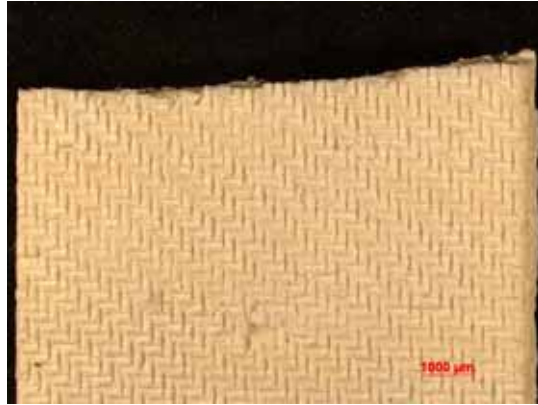
Figure B.179: Fracture surface of the N610/LaPO₄/Al₂O₃ specimen with 8ply HSW subjected subjected to creep test at 30 MPa in steam at 1100 °C ($t_f = 16.1$ h).

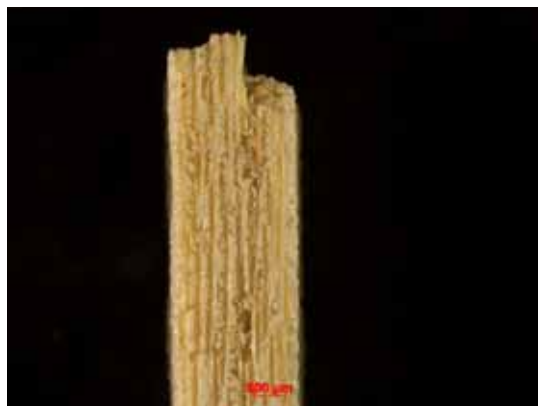
Figure B.181: Fracture surface of the N610/LaPO₄/Al₂O₃ specimen with 8ply HSW subjected subjected to creep test at 30 MPa in steam at 1100 °C ($t_f = 16.1$ h).

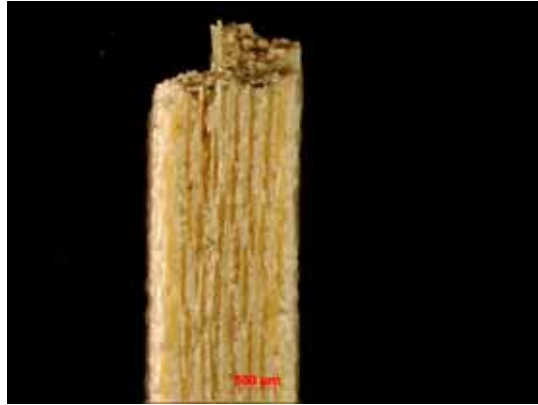
Figure B.182: Fracture surface of the N610/LaPO₄/Al₂O₃ specimen with 8ply HSW subjected subjected to creep test at 30 MPa in steam at 1100 °C ($t_f = 16.1$ h).

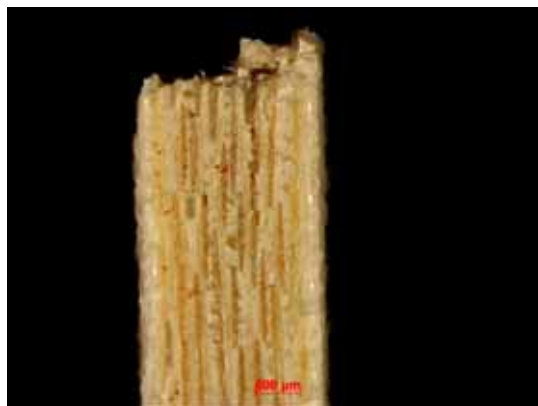
Figure B.184: Fracture surface of the N610/LaPO₄/Al₂O₃ specimen with 8ply HSW subjected subjected to creep test at 30 MPa in steam at 1100 °C ($t_f = 16.1$ h).

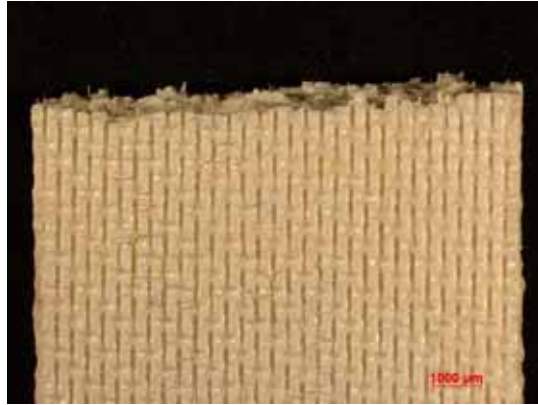
Figure B.185: Fracture surface of the N610/LaPO₄/Al₂O₃ specimen with 8ply HSW subjected subjected to creep test at 40.5 MPa in air at 1100 °C ($t_f = 3.34$ h).

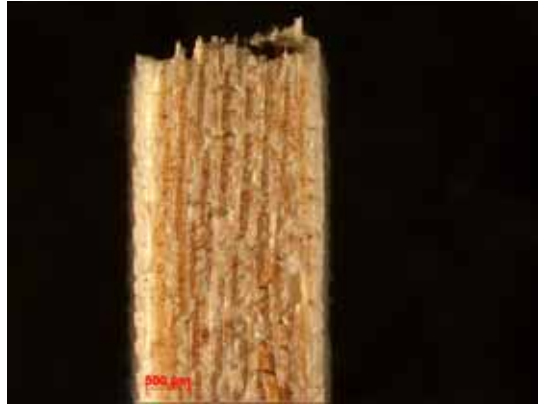
Figure B.188: Fracture surface of the N610/LaPO₄/Al₂O₃ specimen with 8ply HSW subjected subjected to creep test at 40.5 MPa in air at 1100 °C ($t_f = 3.34$ h).

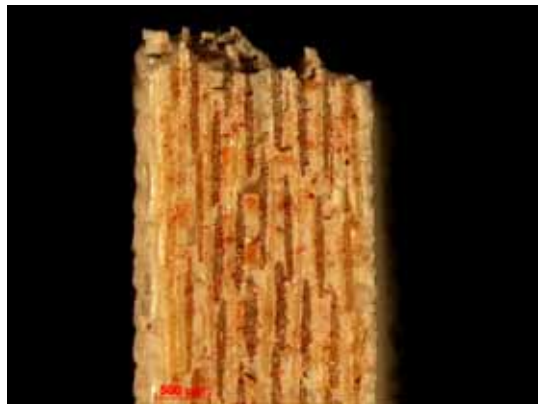
Figure B.190: Fracture surface of the N610/LaPO₄/Al₂O₃ specimen with 8ply HSW subjected subjected to creep test at 40.5 MPa in air at 1100 °C ($t_f = 3.34$ h).

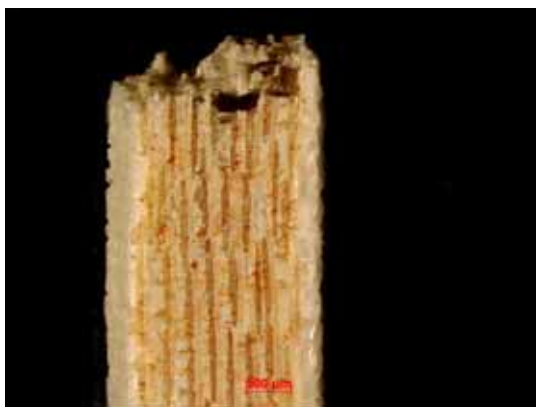
Figure B.191: Fracture surface of the N610/LaPO₄/Al₂O₃ specimen with 8ply HSW subjected subjected to creep test at 40.5 MPa in air at 1100 °C ($t_f = 3.34$ h).

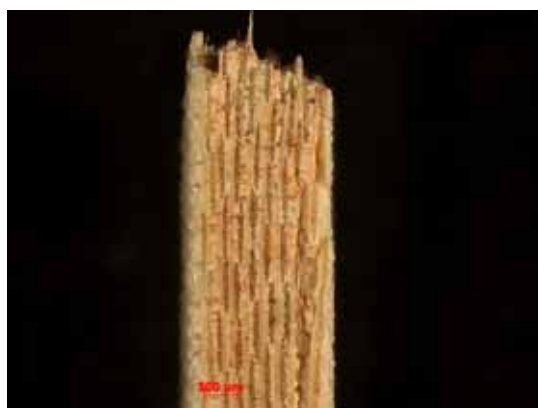
Figure B.194: Fracture surface of the N610/LaPO₄/Al₂O₃ specimen with 8ply HSW subjected subjected to creep test at 40.5 MPa in steam at 1100 °C ($t_f = 0.01$ h).

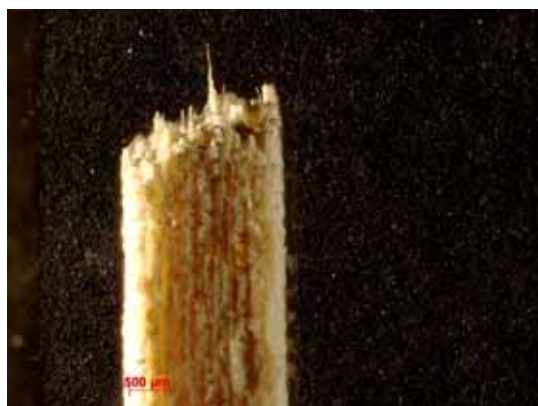
Figure B.195: Fracture surface of the N610/LaPO₄/Al₂O₃ specimen with 8ply HSW subjected subjected to creep test at 40.5 MPa in steam at 1100 °C ($t_f = 0.01$ h).

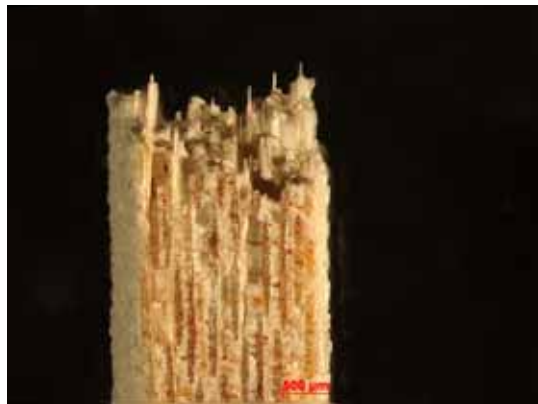
Figure B.198: Fracture surface of the N610/LaPO₄/Al₂O₃ specimen with 8ply HSW subjected subjected to creep test at 40.5 MPa in steam at 1100 °C ($t_f = 0.01$ h).

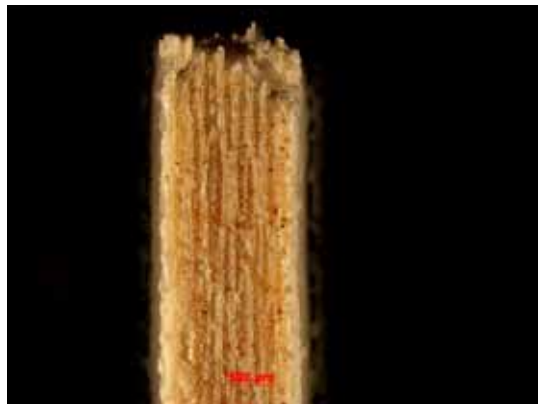
Figure B.201: Fracture surface of the N610/LaPO₄/Al₂O₃ specimen with 8ply HSW subjected subjected to creep test at 61 MPa in air at 1100 °C ($t_f = 3.42$ h).

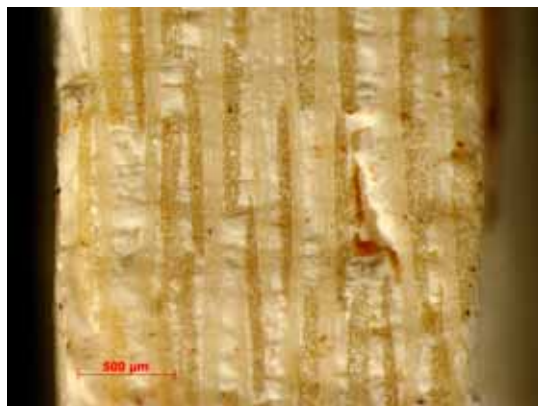
Figure B.202: Side view of the virgin N610/LaPO₄/Al₂O₃-AlOCl specimen with 8ply HSW.

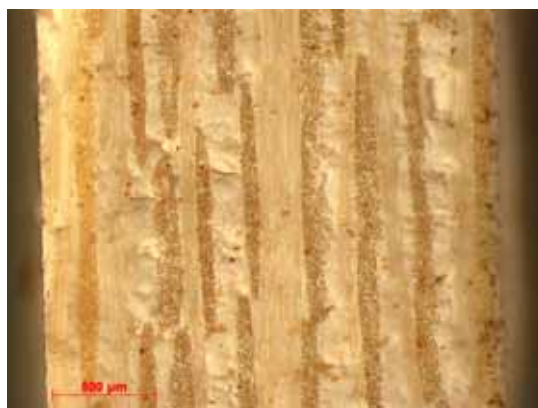
Figure B.203: Side view of the virgin N610/LaPO₄/Al₂O₃-AlOCl specimen with 8ply HSW.

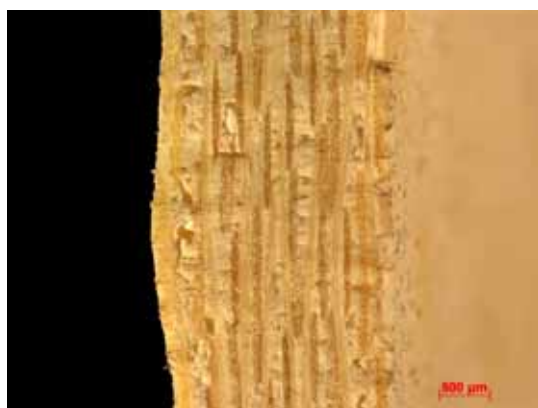
Figure B.204: Side view of the virgin N610/LaPO₄/Al₂O₃-AlOCl specimen with 8ply HSW.

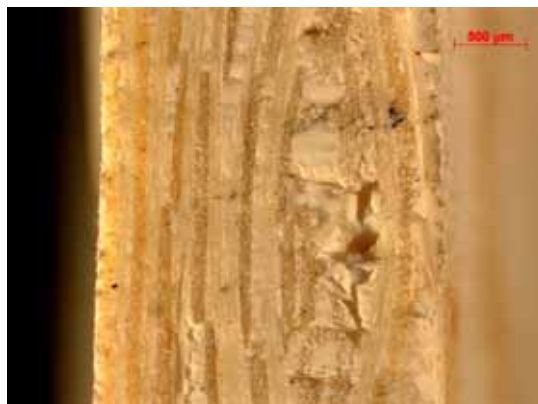
Figure B.205: Side view of the virgin N610/LaPO₄/Al₂O₃-AlOCl specimen with 8ply HSW.

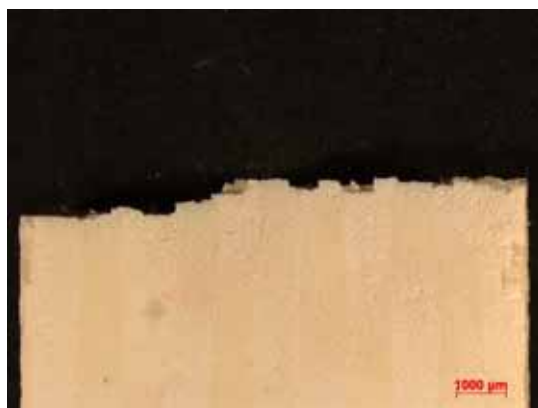
Figure B.206: Fracture surface of the N610/LaPO₄/Al₂O₃-AlOCl specimen with 8ply HSW subjected tension to failure in laboratory air at 1100 °C.

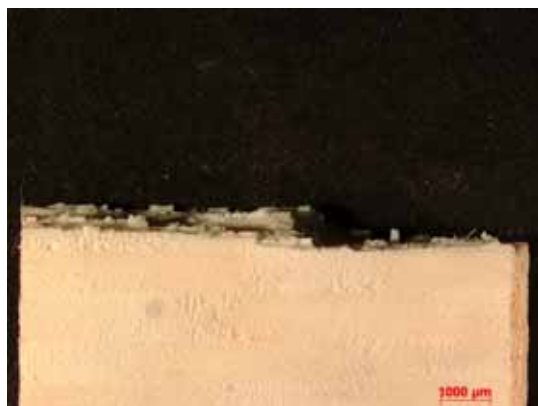
Figure B.207: Fracture surface of the N610/LaPO₄/Al₂O₃-AlOCl specimen with 8ply HSW subjected tension to failure in laboratory air at 1100 °C.

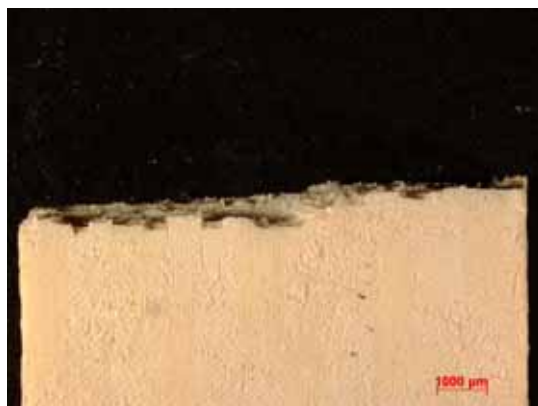
Figure B.210: Fracture surface of the N610/LaPO₄/Al₂O₃-AlOCl specimen with 8ply HSW subjected tension to failure in laboratory air at 1100 °C.

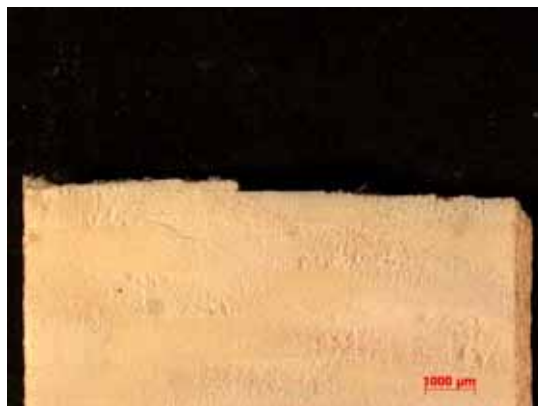
Figure B.211: Fracture surface of the N610/LaPO₄/Al₂O₃-AlOCl specimen with 8ply HSW subjected tension to failure in laboratory air at 1100 °C.

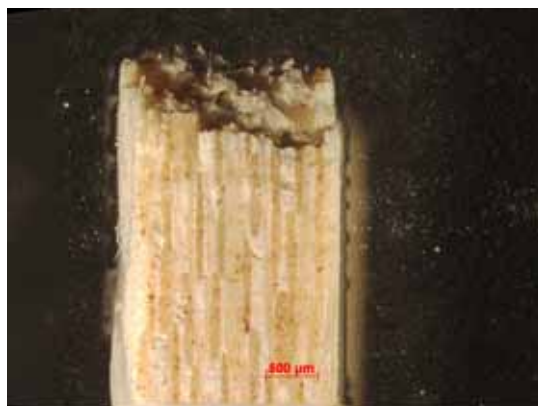
Figure B.213: Fracture surface of the N610/LaPO₄/Al₂O₃-AlOCl specimen with 8ply HSW subjected tension to failure in laboratory air at 1100 °C.

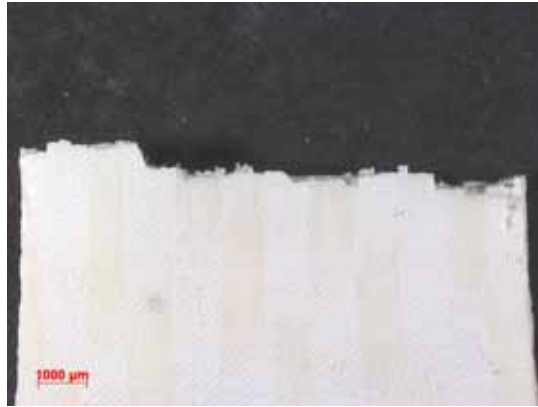
Figure B.214: Fracture surface of the N610/LaPO₄/Al₂O₃-AlOCl specimen with 8ply HSW subjected subjected to creep test at 32 MPa in air at 1100 °C ($t_f > 100$ h).

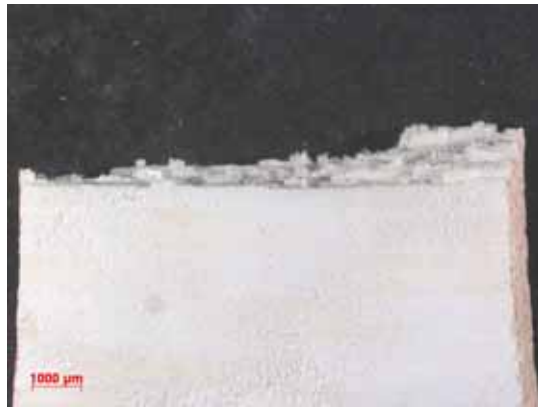
Figure B.215: Fracture surface of the N610/LaPO₄/Al₂O₃-AlOCl specimen with 8ply HSW subjected subjected to creep test at 32 MPa in air at 1100 °C ($t_f > 100$ h).

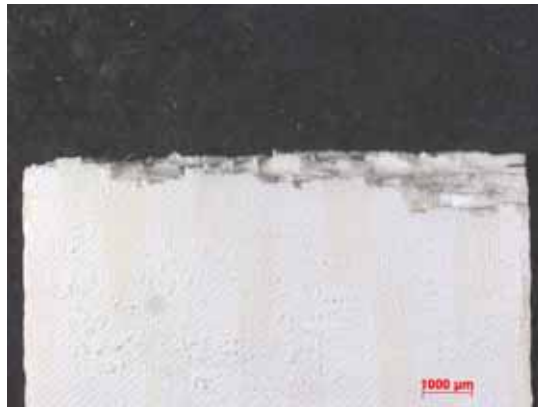
Figure B.218: Fracture surface of the N610/LaPO₄/Al₂O₃-AlOCl specimen with 8ply HSW subjected subjected to creep test at 32 MPa in air at 1100 °C ($t_f > 100$ h).

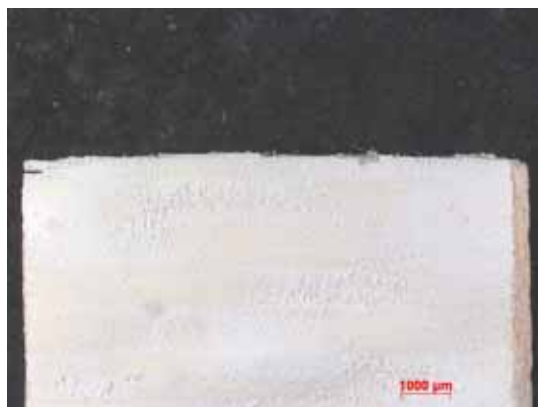
Figure B.219: Fracture surface of the N610/LaPO₄/Al₂O₃-AlOCl specimen with 8ply HSW subjected subjected to creep test at 32 MPa in air at 1100 °C ($t_f > 100$ h).

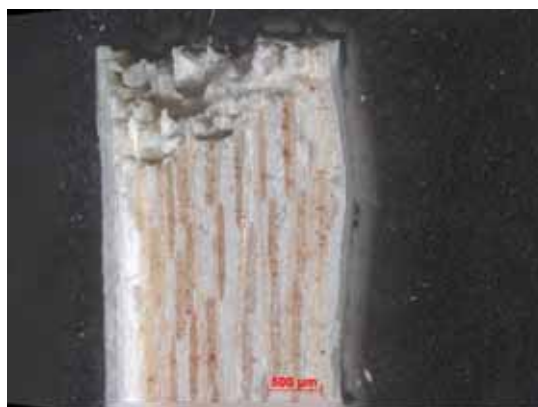
Figure B.220: Fracture surface of the N610/LaPO₄/Al₂O₃-AlOCl specimen with 8ply HSW subjected subjected to creep test at 32 MPa in air at 1100 °C ($t_f > 100$ h).

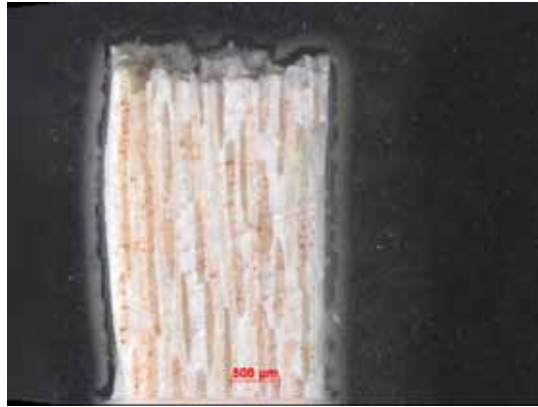
Figure B.221: Fracture surface of the N610/LaPO₄/Al₂O₃-AlOCl specimen with 8ply HSW subjected subjected to creep test at 32 MPa in air at 1100 °C ($t_f > 100$ h).

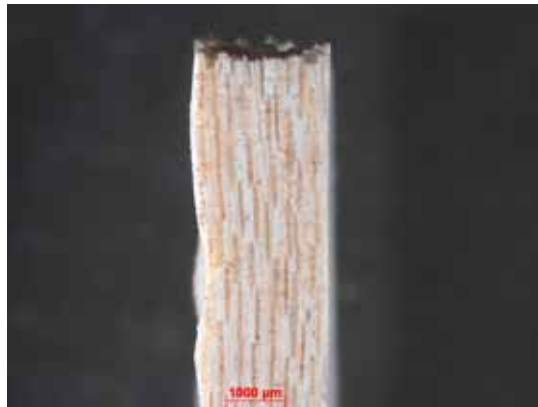
Figure B.222: Fracture surface of the N610/LaPO₄/Al₂O₃-AlOCl specimen with 8ply HSW subjected subjected to creep test at 32 MPa in air at 1100 °C ($t_f > 100$ h).

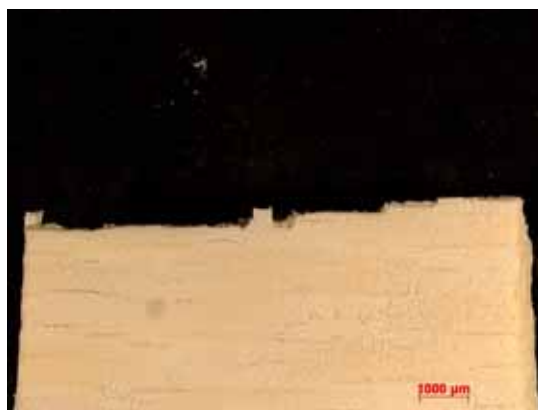
Figure B.224: Fracture surface of the N610/LaPO₄/Al₂O₃-AlOCl specimen with 8ply HSW subjected subjected to creep test at 32 MPa in steam at 1100 °C ($t_f = 3.47$ h).

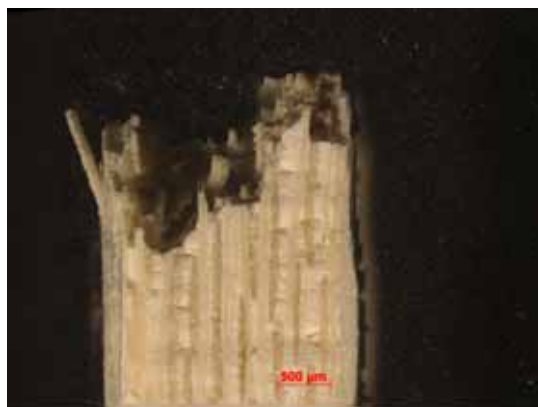
Figure B.225: Fracture surface of the N610/LaPO₄/Al₂O₃-AlOCl specimen with 8ply HSW subjected subjected to creep test at 32 MPa in steam at 1100 °C ($t_f = 3.47$ h).

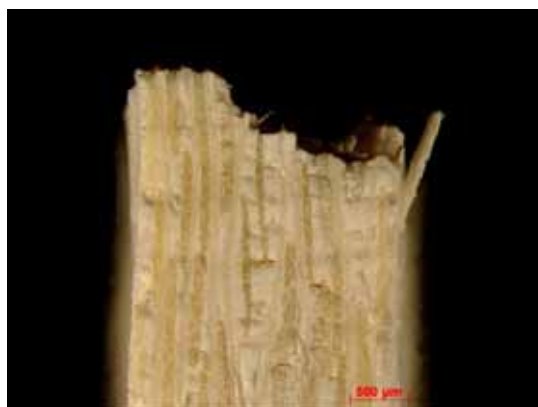
Figure B.226: Fracture surface of the N610/LaPO₄/Al₂O₃-AlOCl specimen with 8ply HSW subjected subjected to creep test at 32 MPa in steam at 1100 °C ($t_f = 3.47$ h).

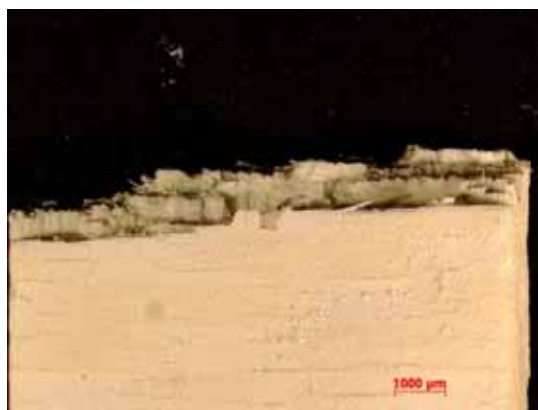
Figure B.228: Fracture surface of the N610/LaPO₄/Al₂O₃-AlOCl specimen with 8ply HSW subjected subjected to creep test at 32 MPa in steam at 1100 °C ($t_f = 3.47$ h).

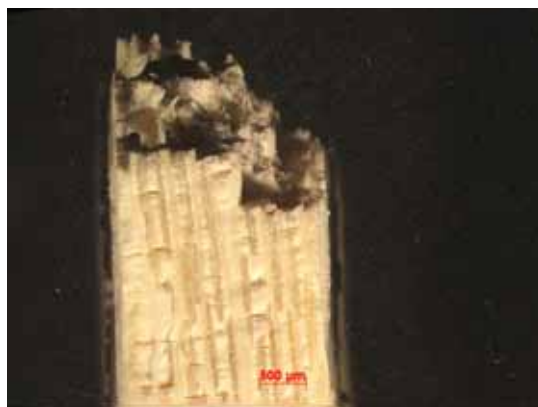
Figure B.229: Fracture surface of the N610/LaPO₄/Al₂O₃-AlOCl specimen with 8ply HSW subjected subjected to creep test at 32 MPa in steam at 1100 °C ($t_f = 3.47$ h).

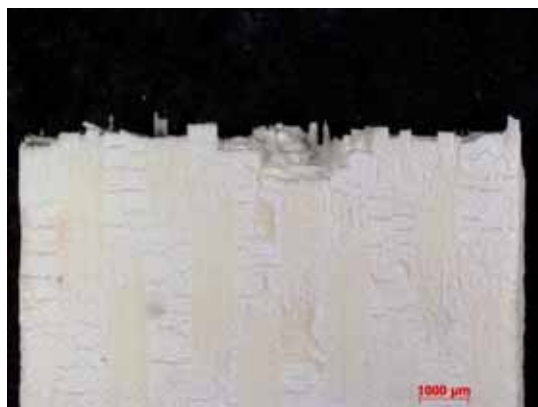
Figure B.231: Fracture surface of the N610/LaPO₄/Al₂O₃-AlOCl specimen with 8ply HSW subjected subjected to creep test at 48 MPa in steam at 1100 °C ($t_f = 2.06$ h).

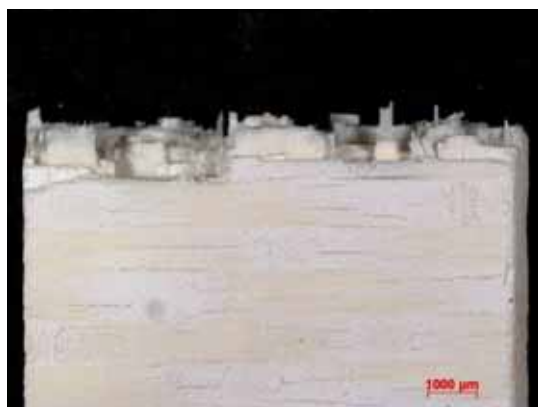
Figure B.232: Fracture surface of the N610/LaPO₄/Al₂O₃-AlOCl specimen with 8ply HSW subjected subjected to creep test at 48 MPa in steam at 1100 °C ($t_f = 2.06$ h).

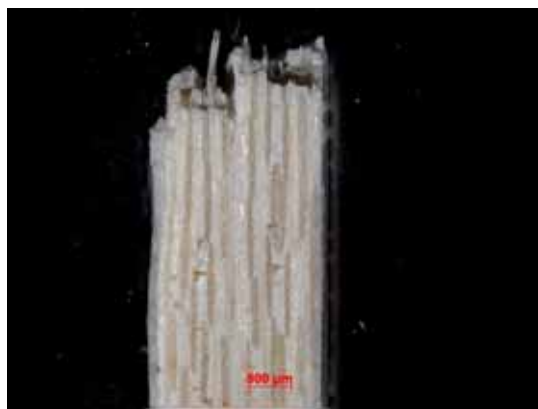
Figure B.233: Fracture surface of the N610/LaPO₄/Al₂O₃-AlOCl specimen with 8ply HSW subjected subjected to creep test at 48 MPa in steam at 1100 °C ($t_f = 2.06$ h).

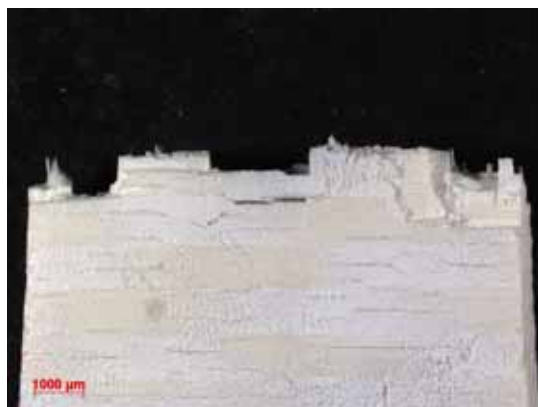
Figure B.235: Fracture surface of the N610/LaPO₄/Al₂O₃-AlOCl specimen with 8ply HSW subjected subjected to creep test at 48 MPa in steam at 1100 °C ($t_f = 2.06$ h).

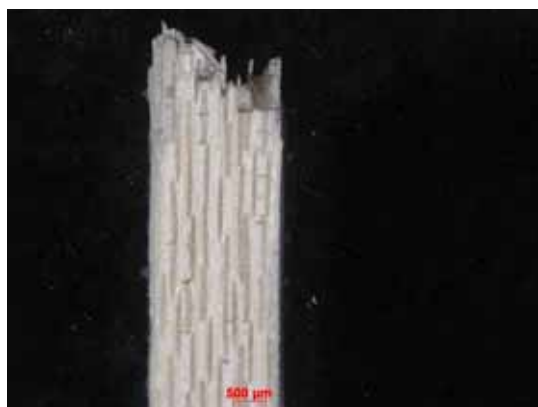
Figure B.236: Fracture surface of the N610/LaPO₄/Al₂O₃-AlOCl specimen with 8ply HSW subjected subjected to creep test at 48 MPa in steam at 1100 °C ($t_f = 2.06$ h).

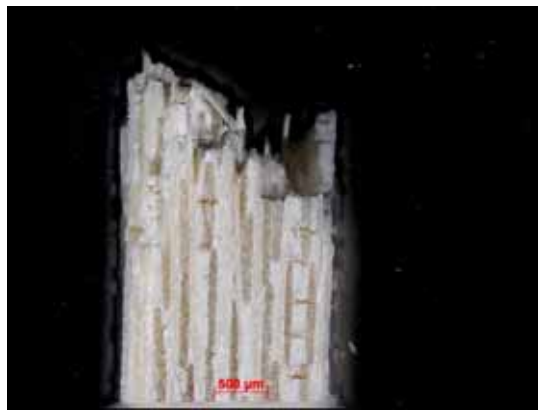
Figure B.237: Fracture surface of the $\text{N610/LaPO}_4/\text{Al}_2\text{O}_3\text{-AlOCl}$ specimen with 8ply HSW subjected subjected to creep test at 48 MPa in steam at 1100 °C ($t_f = 2.06$ h).
